## HAIL DAMAGE REPAIR

Greenville News, Taylors, SC

Gravel BUR with Emulsion Coating

Soprema PVC, 20Y NDl to 2012 IECC insulation requirements

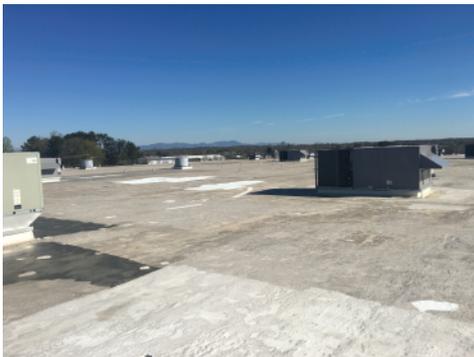
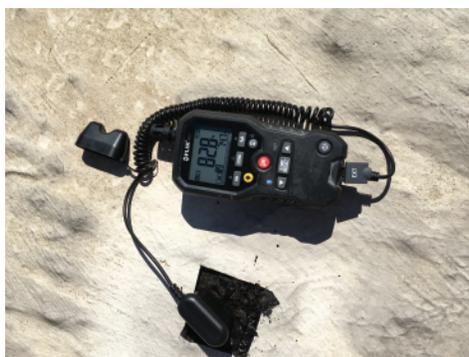
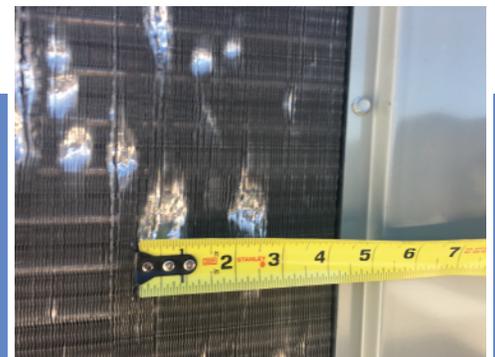
Following a hail event in late March of 2016, EnviroShield was called out by the property owner to address leaks. Upon arrival, EnviroShield noticed that the roof surface seemed to be punctured and the HVAC units showed signs of denting. EnviroShield requested ECC come to inspect the property. Unfortunately, the property owner had filed an insurance claim prior to ECC inspecting the roof. ECC prefers to inspect and discuss their findings with the property owner prior to any decision being made regarding a potential insurance claim. In many cases, our findings do not warrant filing a claim or the property owner's coverage is inadequate or the amount of the deductible could all impact the decision making for the property owner on whether to proceed. Filing could affect the property owner's premium even if no settlement is made as the insurance company incurs claim costs regardless of the outcome.

In order to determine the condition of the underlying material, ECC met the insurance company's construction consultant one evening and performed a thermal imaging scan. As a certified thermographer, Mr. Wilson was able to perform the scan without the insurance company incurring the expense of hiring a third party consultant. The next day, core samples were taken and confirmed that the substrate had sustained moisture damage after the hail impacts which would

need to be addressed in the scope of work. Once the damage was assessed, ECC began working on developing a scope of work utilizing the insurance valuing software, Xactimate. In addition to addressing the roof and HVAC damage, ECC discussed the specific operations with the tenant and found that their critical machinery runs all three shifts. Removing the old roof screws would allow fine dust particles into the building that could disturb their production. ECC worked with the insurance company and was able to include interior containment to protect the machinery during the roofing project.
