HAIL DAMAGE REPAIR

Mitchell Gold Company, Statesville, NC

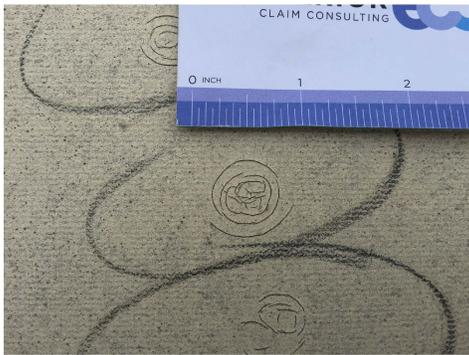
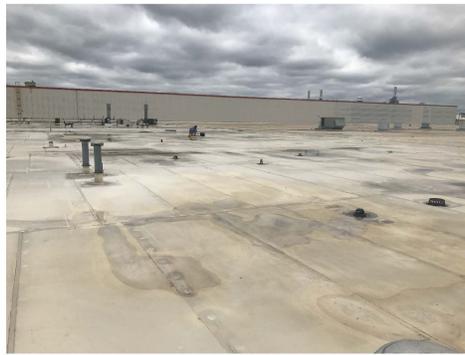
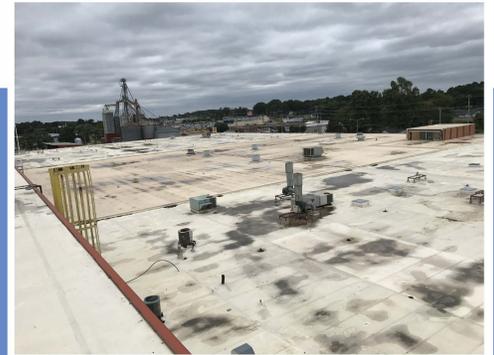
After a couple days of inspections, it was determined that the Fibertite membrane sections had significant hail damage. ECC also performed an impedance scan to determine the level, if any, of moisture in the substrate. Performing these tests help determine the extent of damage and in turn the scope of work for repairs. ECC used the data collected while on location and put together their Project Portfolio for Mitchell Gold Company's insurance company. This included the forensic roof survey, CAD drawing, core samples, moisture survey using Tramex Dec Scanner and an estimate for repairs using Xactimate, the valuing software used by the majority of insurance companies.
