HAIL DAMAGE REPAIR

ABB Group - Baldor, Greenville, SC

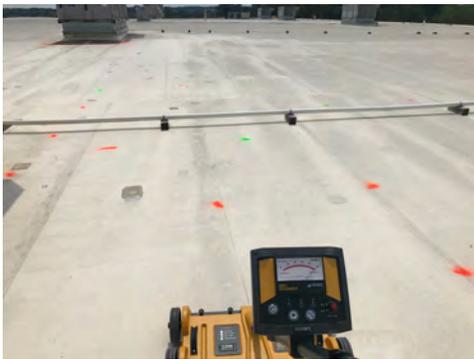
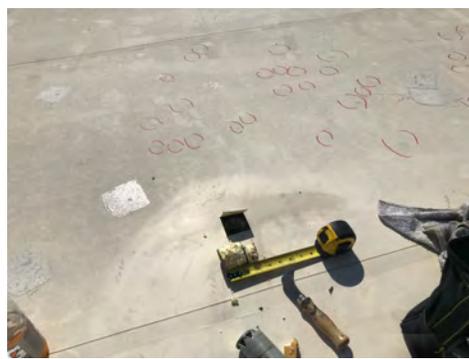
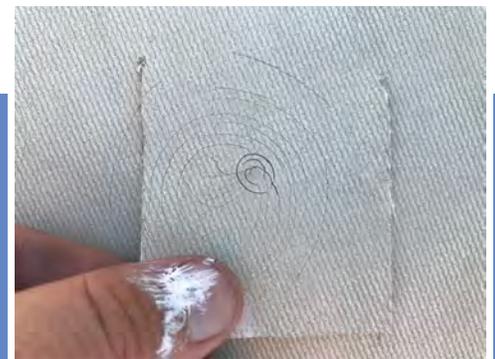
Within a couple of weeks, Andrew and fellow ECC consultant Brent Fillers visited Greenville and performed an initial inspection of the roof membrane at Baldor to confirm that the roof was damaged as a result of hail. After just a few moments on the roof, it was obvious that the property had extensive damage to the Fibertite membrane. A meeting between the local management team at Baldor, Summit BSR and ECC took place to discuss the damage discovered along with how ECC would support Summit BSR through the insurance claim process. With Baldor being a large corporation, all parties agreed that the corporate office should be brought onboard before proceeding. This allowed all parties to be on the same page and ECC was able to answer questions before giving the green light to move forward.

ECC then got to work, spending 2 days at the facility to gather information such as measurements and core samples. The roof had multiple sections with varying substrates, one of which contained a built-up roof. The built-up roof core sample was saved and sent to a testing facility to determine if any asbestos was present, as this appeared to have been the original roof, which was installed in the 1970's.

Additionally, a Tramex roof moisture scanner was used to determine the amount of moisture, if any, in the roofing substrate. While the moisture scan showed only small signs of moisture, it was determined that the built-up roof did contain traces of asbestos. As a result, appropriate steps would be required to remove this portion of the roofing system.

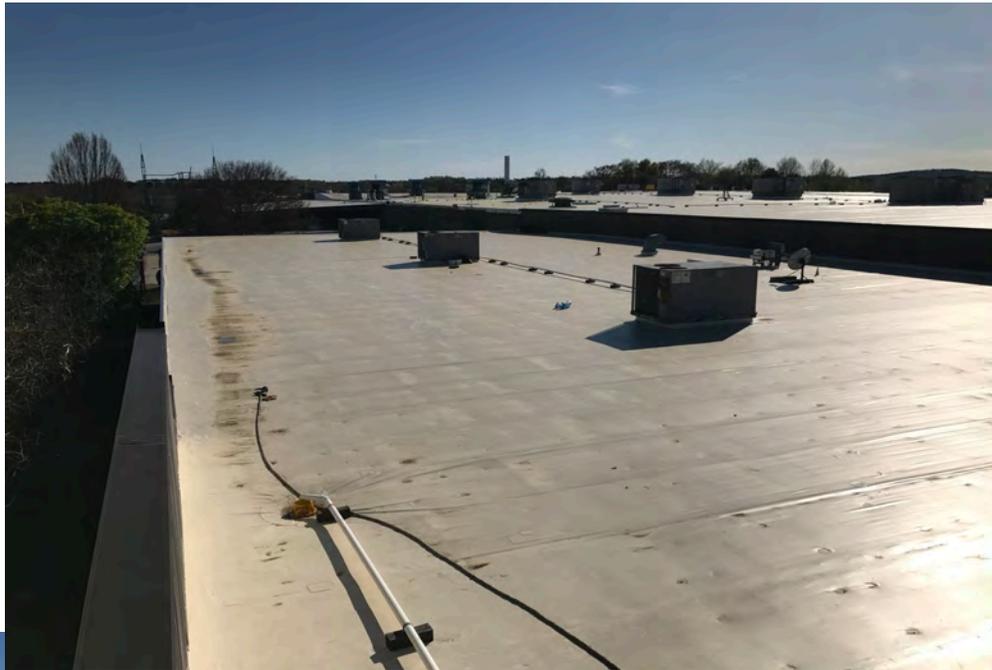
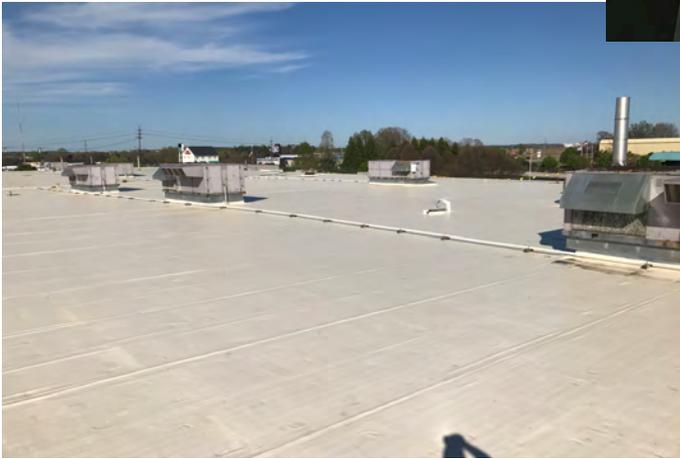
Now that the project was funded, Summit BSR was able to begin pre-construction. They met with Baldor to determine the final scope details, reviewed the build plan and scheduled the work to begin. ECC documented changes to the scope and assisted Summit BSR in getting the change orders approved with both Baldor and their insurance company. Progress billing with AIA documentation was used to expedite payment with the insurance company which kept Baldor from using their own funds to cash flow the project. Once the work was complete, ECC completed project completion documentation to be submitted to Baldor's insurance company for final payment release. The contractor scheduled a final inspection with the roofing manufacturer and a 20-year system warranty was presented shortly afterwards.

- Baldor received a brand new Fibertite roofing system with a 20-year warranty valued at well over \$1,000,000 and the only out of pocket cost for Baldor was their deductible
- Local management were heroes praised by corporate for their results in hiring Summit BSR
- Summit BSRs relationship with Baldor improved based on the projects results
- Contractor completed a profitable job without spending additional resources working with the client's insurance company.
