## HAIL DAMAGE REPAIR

Greenville News, Taylors, SC

Gravel BUR with Emulsion Coating

Soprema PVC, 20Y NDl to 2012 IECC insulation requirements

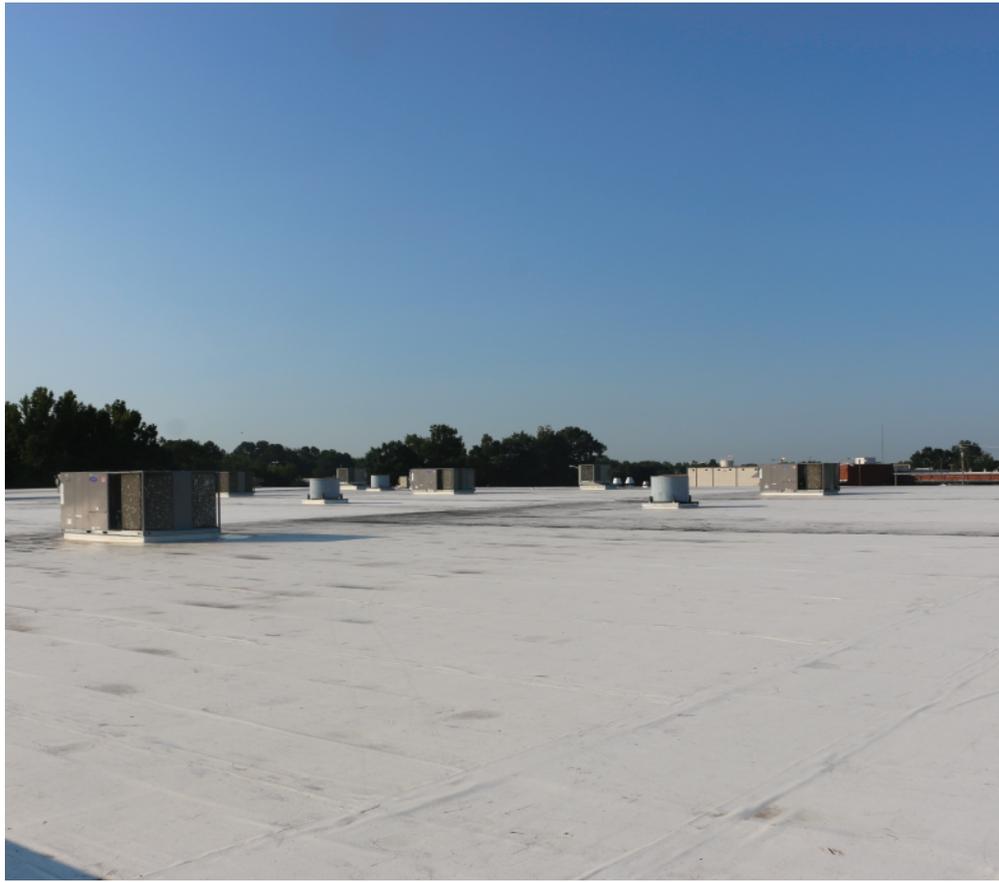
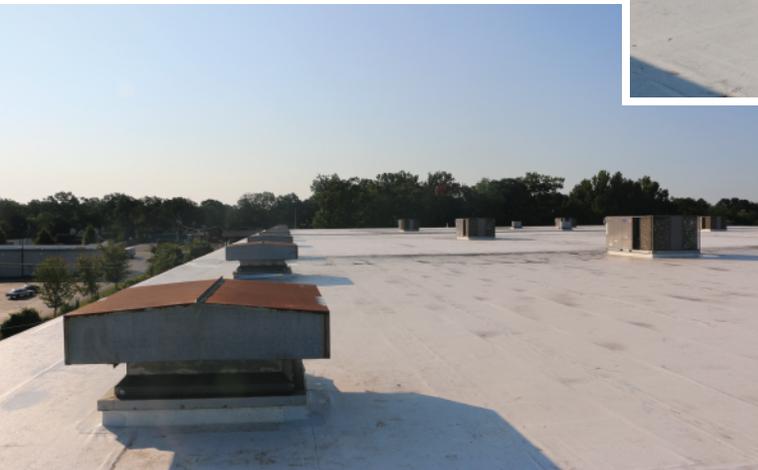
In order to determine the condition of the underlying material, ECC met the insurance company's construction consultant one evening and performed a thermal imaging scan. As a certified thermographer, Mr. Wilson was able to perform the scan without the insurance company incurring the expense of hiring a third party consultant. The next day, core samples were taken and confirmed that the substrate had sustained moisture damage after the hail impacts which would

ECC properly evaluated the scope, worked with the insurance company to avoid any miscommunication between the adjuster/roofing contractor and ensured the property owner's operational needs were addressed. Instead of a \$200k roof coating over a wet existing roof, the owner now has a new 20 year warrantied roof that meets all current codes valued at nearly \$1M and the insurance company reduced their claim costs while having full documentation knowing the project was properly settled. A true "win, win" result.
