HAIL DAMAGE REPAIR

Mitchell Gold Company, Statesville, NC

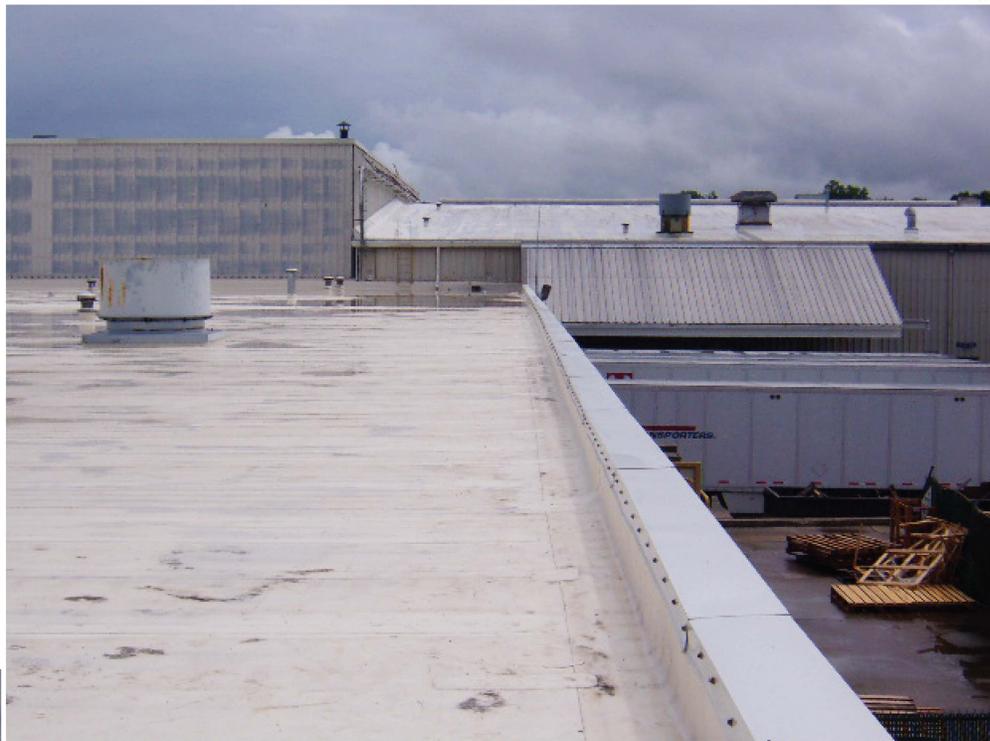
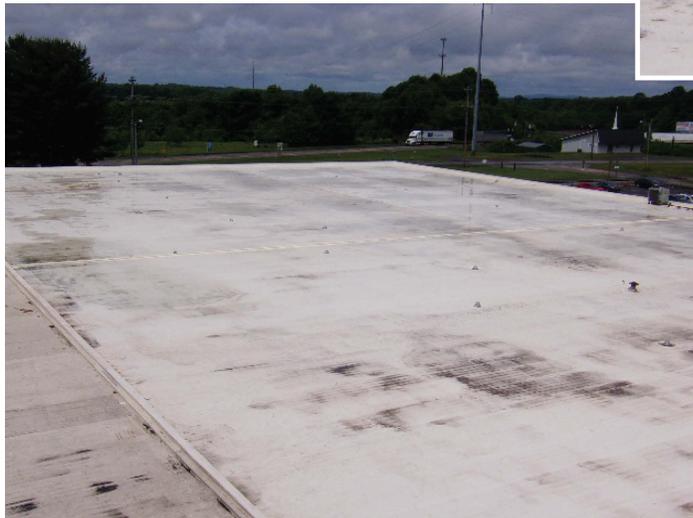
After a couple days of inspections, it was determined that the Fibertite membrane sections had significant hail damage. ECC also performed an impedance scan to determine the level, if any, of moisture in the substrate. Performing these tests help determine the extent of damage and in turn the scope of work for repairs. ECC used the data collected while on location and put together their Project Portfolio for Mitchell Gold Company's insurance company. This included the forensic roof survey, CAD drawing, core samples, moisture survey using Tramex Dec Scanner and an estimate for repairs using Xactimate, the valuing software used by the majority of insurance companies.

- The property owner was provided a 20 year warrantied roof valued at over \$2 million while having only \$25,000 in out of pocket costs.
- The roofing system installed will allow the property owner to save thousands of dollars annually on energy cost due to increased insulation.
- Insufficient decking was replaced at no additional costs to property owner or contractor.
- Numerous site visits were saved by the insurance adjuster by working with ECC, saving the insurance company time and claim handling costs.
- The roofing contractor completed a profitable job without tying up resources working through the insurance process.
